All-Purpose Remote Transport System (ARTS)

Capabilities Demonstration

24-26 September 2001

Night Vision & Electronic Sensors Directorate (NVESD)
DoD Humanitarian Demining Research & Development Program

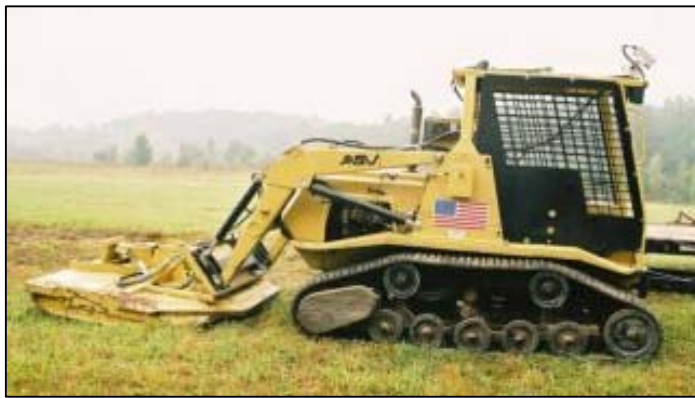
Picture 1 – ARTS with brush cutter

The ARTS consists of a prime mover (a Posi-Track™ MD70 tractor, picture 1), the Operator Control Unit (OCU, picture 2), and various tools. Tool attachments include a brush cutter (picture 1), a bucket (picture 4), pallet forks (picture 4), and a backhoe (picture 5). There are more tools available for this system such as a plow, a range clearance blade, and a water cannon, which were not demonstrated. Two cameras on top of the tractor (one camera faces forward (picture 6) and the other rearward (picture 7)) provide operational visibility when operating the vehicle remotely.

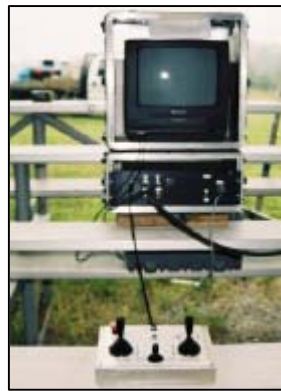
Picture 2 – OCU

The OCU is developed by ARA and provides remote operations of all tractor functions, including engine start/stop, propulsion, lights, and all tool operations. The OCU is comprised of a radio for transmitting command signals to the tractor, a receiver for audio/video signals transmitted from the tractor, a joystick control box, a television monitor with built-in videocassette recorder, an antenna (picture 3, which can be mounted on a portable tripod), and an external generator (minimum of 1kW, not included with the system). The OCU (without the antenna) is packaged in a heavy-duty, weather-tight, shock-isolated case for rugged durability. Additionally, the OCU case contains operator manuals and calibration cables.

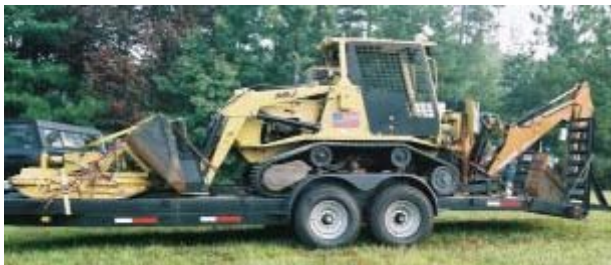
Picture 12- ARTS with tools on trailer

The system was transported on a 24ft trailer that was towed by a commercial Ford F-450 heavy-duty truck to the NVESD/CM test site. The ARTS with all of its tools loaded on the trailer is shown below in picture 12. For better utilization of trailer space and limiting the number of support vehicles required, the tools were stacked upon one another, see picture 13 below. The system does not have any transportation restrictions and does not require highway permits to be transported over land.

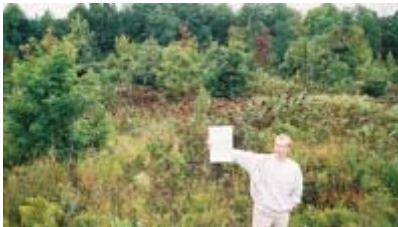
Picture 26 – Category 3 vegetation

The demonstration site consisted of dense sumac brush (up to 2m in height) and various trees on a slightly sloping terrain, see pictures 26 and 27. The variety of trees consisted of gum, maple, and oak and the majority of the trees were 10cm in diameter or less. The site contained one maple tree that was 23cm in diameter, which is considered to be a category 4 vegetation. The site was damp from the previous night's heavy rain, which made a lot of the mulch cling to the cutter rather than being blown away from the cutter. The ARTS cut an area of 36m x 28m in 60 minutes, achieving a cutting rate of 16.8m²/minute. Pictures 28 and 29 show the site after the ARTS cleared the vegetation. The ARTS left the majority of the site with a layer of mulch ranging from 2.5 to 7.5cm thick and a few spots with mulch piles ranging from 15cm to 23cm thick. Also, the ARTS left vegetation stumbls intermixed with the mulch. The 2.5cm diameter stumbls were left as tall as 30cm in height and the 5cm diameter stumbls were left as tall as 1m in height. The 23cm maple tree was cut down to 1m, see picture 30. The brush cutter, at times was underpowered because the cutter was overpowered by the amount of foliage and brush that were in the cutter. About 30 minutes into the operation, the foliage that came in contact with the ARTS depressed the emergency stop button. The stop button had to be manually pulled out in order for the ARTS to continue with operations, see picture 31. If this was an actual minefield, this situation could be a dangerous situation for the operator. The contractor recommended that mounting a cage around the stop button would prevent future accidental stops of the ARTS. The ARTS demonstrated clearing category 3 vegetation.

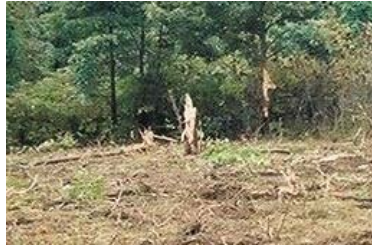
Picture 30 – 23cm diameter maple trunk

The ARTS performed well in clearing vegetation and navigating through terrain from category 1 (easy) through category 3 (difficult). A 23cm diameter tree was cut during category 3 operations. The brush cutter does not have floating capabilities, but with a trained operator, adjustments were made to control the cutter height to allow the cutter to follow the contour of the terrain. The operator's visibility of the ARTS was limited to only what the cameras were

The ARTS demonstrated the capability of clearing category 1 to 3 vegetation and also clearing a 23cm diameter maple tree, which is considered to be a category 4 vegetation. The ARTS demonstrated a clearance rate of approximately 1530m²/hour of the category 2 vegetation.

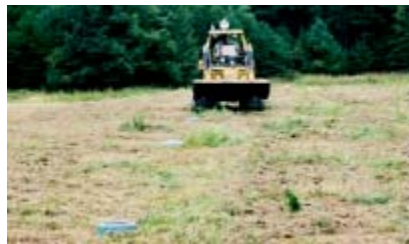
Picture 36 – Surface laid AT mine lane

Three AT mines with smoke fuzes were surface laid in a 25m by 3m lane, see picture 36. The operator manually drove the ARTS over the mines, see picture 37. The track activated all three smoke fuzes. The result demonstrated that the track applied sufficient force to activate the surface laid AT mines.

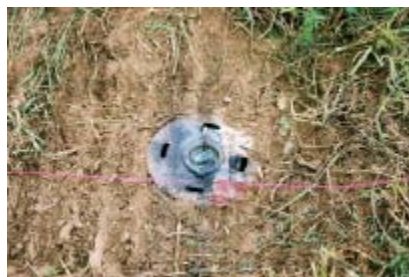
Picture 38 – Activated AT mine

Three AT mines with smoke fuzes were buried flush to the ground. The operator manually drove the ARTS system over the flush laid mines with the rubber track. Only one mine was activated when the ARTS teetered back on the mine while the track encountered a mound on the ground, picture 38 shows the functioned AT mine. Picture 39 shows a non-activated AT mine that was run over with the track.

On a level surface, the track would normally exert only 2psi. However, if there are ruts or bumps in the ground and the tractor is resting on them, then the highest point on the ground would be carrying most of the tractor's weight, therefore exerting greater than the rated 2psi of pressure at that point. The possibility for the ARTS to activate mines is less when the mines are buried in the ground as compared to when the mines are above the ground.

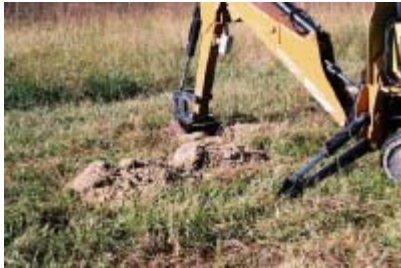
Picture 40 – Backhoe digging up dirt

ARA personnel demonstrated the backhoe operation by excavating some dirt. Pictures 40-42 show the backhoe in operation. The excavator can dig as deep as 2.5m deep. The excavation was operated remotely through the OCU. ARA personnel gave each Humanitarian Demining team member an opportunity and instructions on how to operate the backhoe. Every member was successful in learning how to operate the backhoe within 5-15 minutes. However, to become a proficient operator would require additional 8-20 hours of hands-on time, dependent on the trainee's ability.
